# REPORT PROPOSAL 2019 BY HIGGY VASQUEZ

## Lemon Park & Bridge Public Art

# LEMON PARK & BRIDGE MURAL RESTORATION / RE-CREATION

Recommendations and solutions for aging public art at 701 S Lemon St, Fullerton, CA

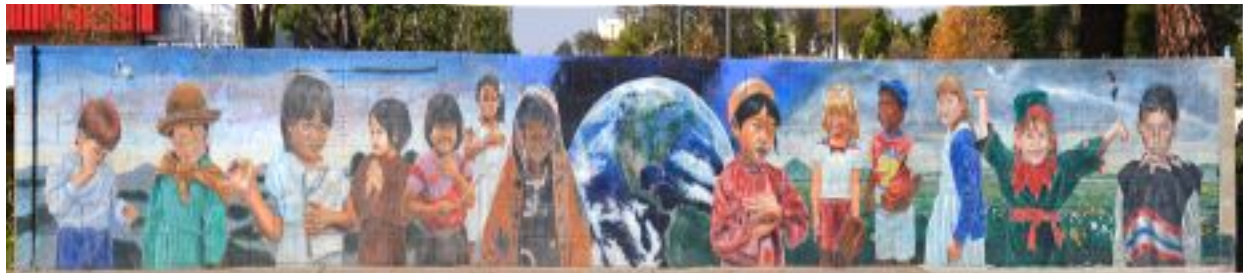
## “Niños del Mundo” Mural by Emigdio Vasquez 1993

(Children of the World) Acrylic on a brick wall 5' x 36'

- Washing, removing decay protectant coat and dirt.
- Cutting out decayed lifted areas scattered throughout the mural.
- Recomposing layers with primer.
- Recolor and repaint from original photography by Emigdio Vasquez documentation.

- Redraw and repaint right end of mural where cinder blocks were replaced
- Clear acrylic polymer coating, with a second coat of two-part Permashield premium protective coating that is anti-graffiti and protects from UV rays.

*Recommendation:* Placing a ground pole to the right, at the end of the mural to protect the cinder block for future from cars.

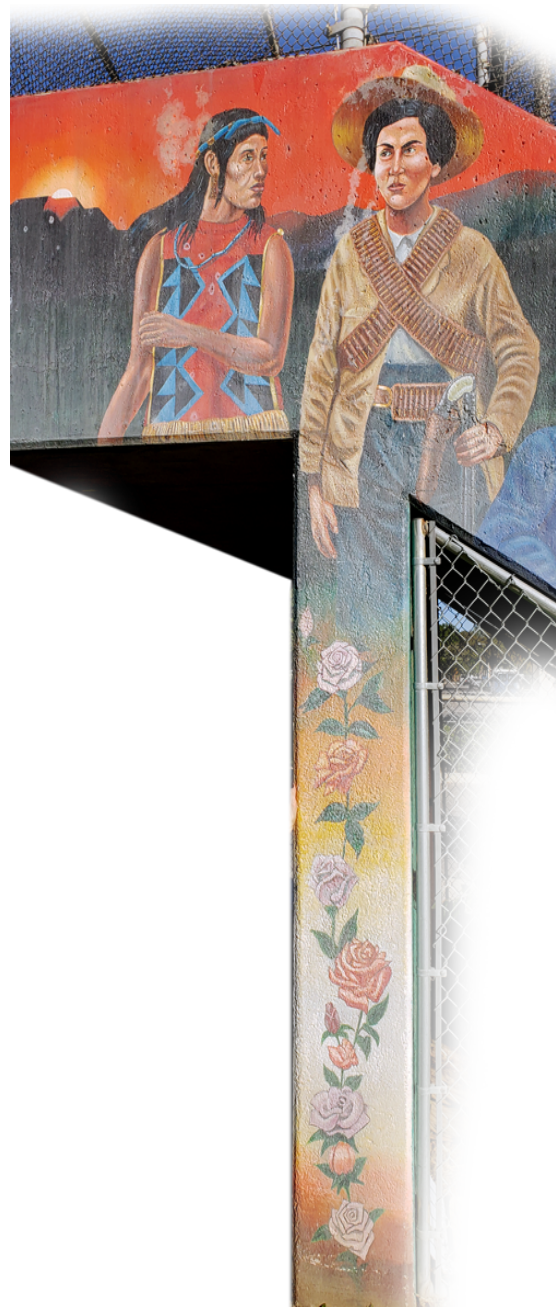
**“Mujeres Latinas” by Emigdio Vasquez 1988  
(Latin Women) Acrylic on a concrete 3’6” x 20’  
Cost: Artist(s) \$7400, Materials \$500**

This mural is oxidized with fading color, and decayed protective coating, causing clouding of images. Much of the background needs recreation as it is decayed to powdering level. Portions of characters need recreation and can be restored. Not recommending polytab as this can be restored. It has minor chipping on a smoother concrete base, not blocks. (see full picture of mural on next page.)

- Careful scraping and sanding to remove oxidized sealant, decay and dirt.
- Primer, recompose exposed patches in layers.
- Artist repaint and recolor to match original photography by Emigdio Vasquez documentation.
- Application of clear acrylic polymer coating, with a second coat of two-part Permashield premium protective coating that is anti-graffiti and protects from UV rays.

*Recommendation:* Consider bark on ground a few feet wide at base of each mural in this area to avoid grass watering next to the mural.

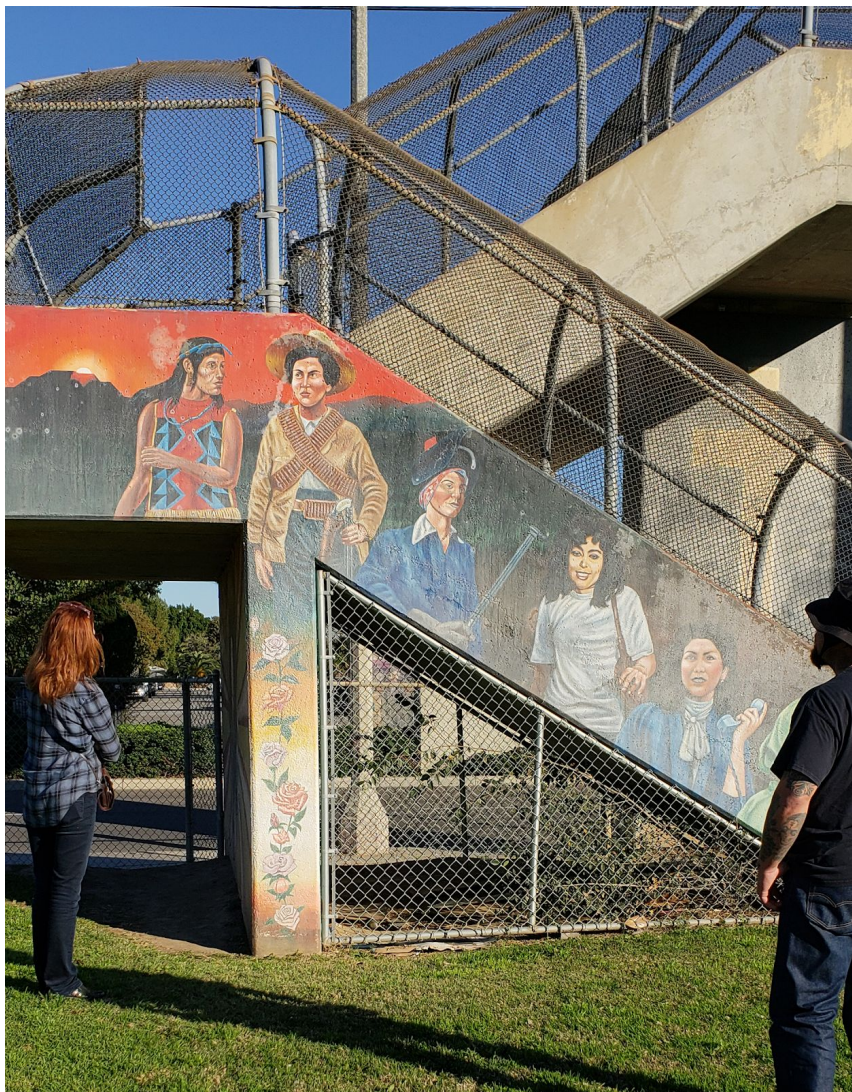
**“Cruising the Past -- Zoot Suit Theme, Classic Car, Lettering and Rose” by the community circa the 1970s wall**

This mural has extreme decay and fading, it is not suitable to paint over the existing paint to restore.

- The solution would be to recreate this mural using polytab mural fabric base and an updated design. Polytab material is resistant to cracking, chipping, and peeling. It doubles the life of the mural into the future and maintains the quality of the mural..

- The wall is scraped and resurfaced prior to applying the polytab. The polytab is attached to the wall with an acrylic polymer gel and smoothed onto the wall. Then the polytab is primed and painted like any other mural wall, readying it in order to paint. Images are redrawn onto the polytab.

- Update Design. Maintain idea images of the old mural, but enhance the design with better fonts, nicer colors, more beautiful roses, a better zoot suit image, and a vintage car. Move images higher on the wall with the ribbon at the bottom with a better layout.

- Apply acrylic polymer coating, with a second coat of two-part Permashield premium protective coating that is anti-graffiti and protects from UV rays.

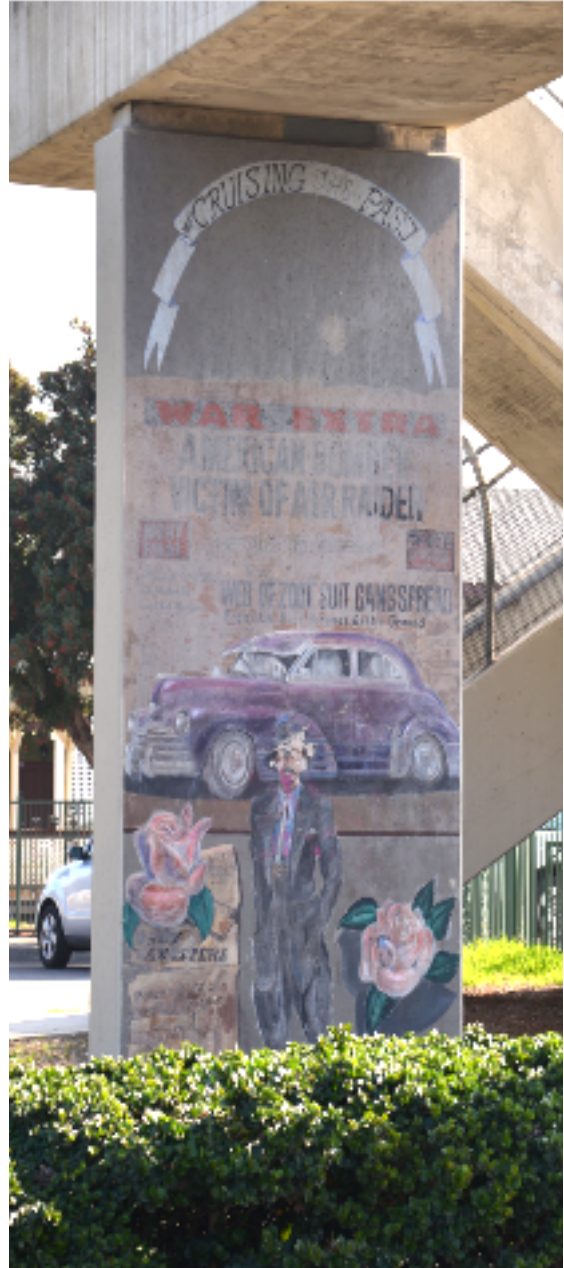
**“Woman and Vintage Car” by the community circa the 1970s**

This mural has declined to a state of non-repair, and has an unstable surface, and spiderweb lifting of the paint. The wall needs to be completely scraped and recreated.

- Update Design. Maintain idea images of the old mural, but enhance the overall design. Design will maintain the current vintage car, but improve the image of the woman to one that is more realistic. Design will improve the dead space of the upper mural, adding a background sunset, light cityscape with palm trees, and strips of clouds fading into an American Flag at the very top. Enhancements to the design will bring it to a higher level matching the Zoot Suit vintage car panel on the other side of the bridge to be equally stunning.
- Polytab will be used for this panel. All images are redrawn onto polytab.
- Apply acrylic polymer coating, with a second coat of two-part Permashield premium protective coating that is anti-graffiti and protects from UV rays.

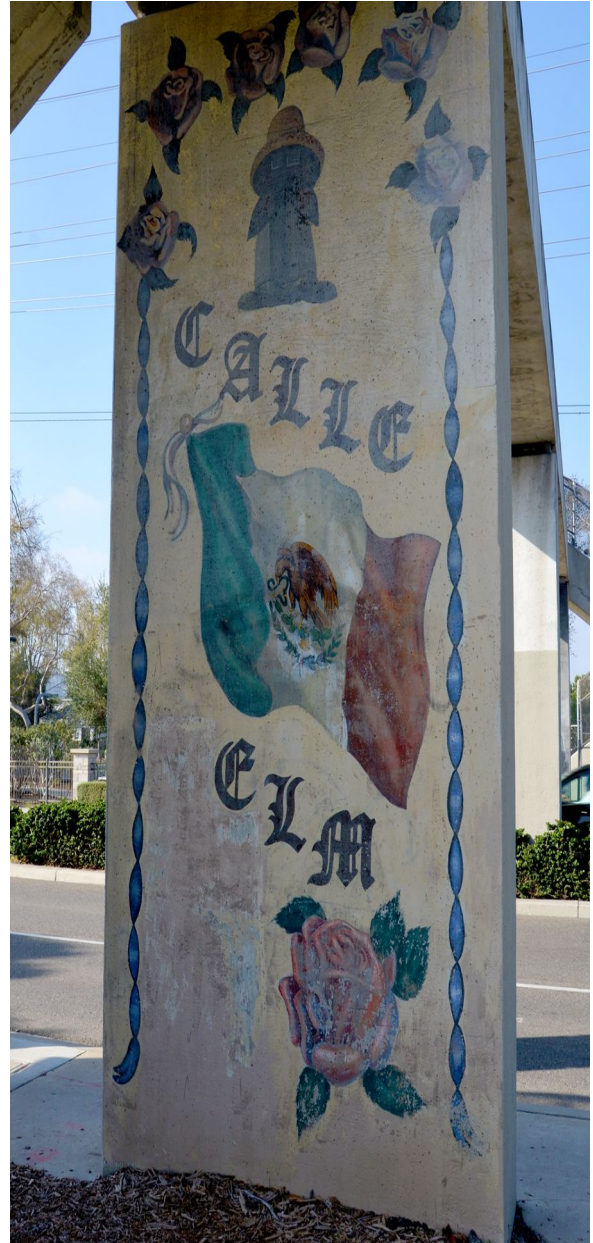
**“Calle Elm” by the community circa the 1970s**

This mural has fading, chipping and peeling. Paint is not excessively lifting and the mural can be restored without redrawing or polytab.

- Scrape with wire brush. Fill and repair chips, nicks, holes.
- Repaint
- Update Design- beautify the roses and match with other roses throughout the overall project and improve colors of the mural.
- Apply acrylic polymer coating, with a second coat of two-part permashield premium protective coating that is anti-graffiti and protects from UV rays.

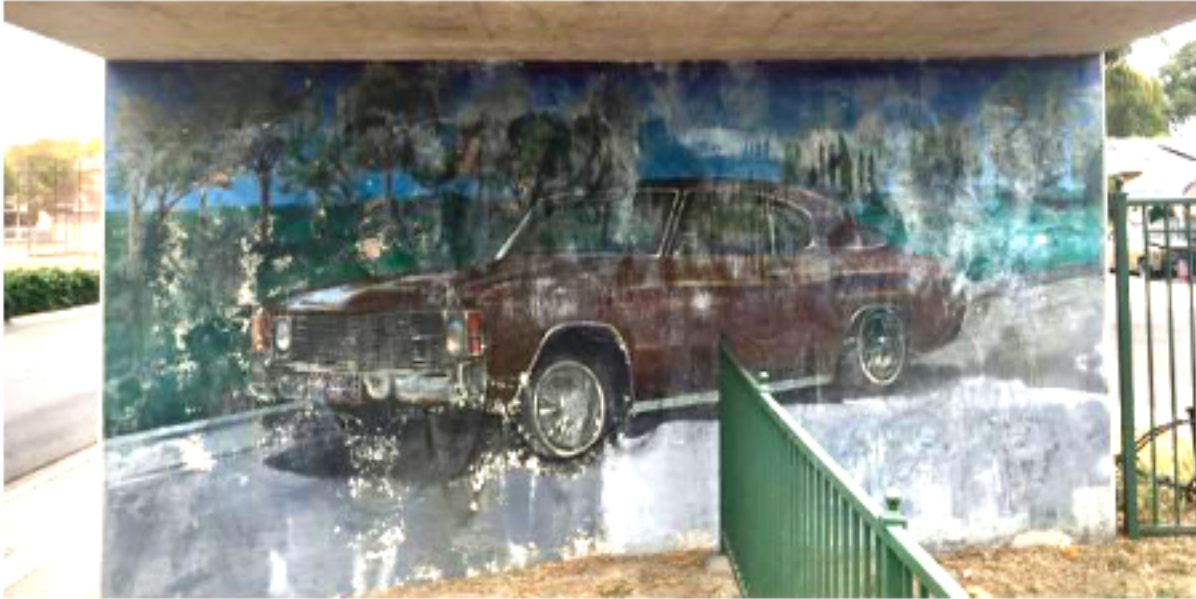
**“Lowrider Car” by the Community Circa 1970’s  
Roughly 120 sq ft Concrete wall -- 16’ 4” x 7’5”**

This mural has extreme decay and fading, it is not suitable to paint over the existing paint. Recommendations:

- Design Update: Improve background and foreground landscape.
- Recreate this mural using polytab mural fabric base. Polytab material is resistant to cracking, chipping, and peeling. It doubles the life of the mural into the future and maintains the quality of the mural..
- The wall is scraped and resurfaced prior to applying the polytab. The polytab is attached to the wall with an acrylic polymer gel and smoothed onto the wall. Then the polytab is primed and painted like any other mural wall, readying it in order to paint. Images are redrawn onto the polytab.

*City Assistance:* Adding bark ground cover to the area around the base of the mural keeps people back from the mural and dry.

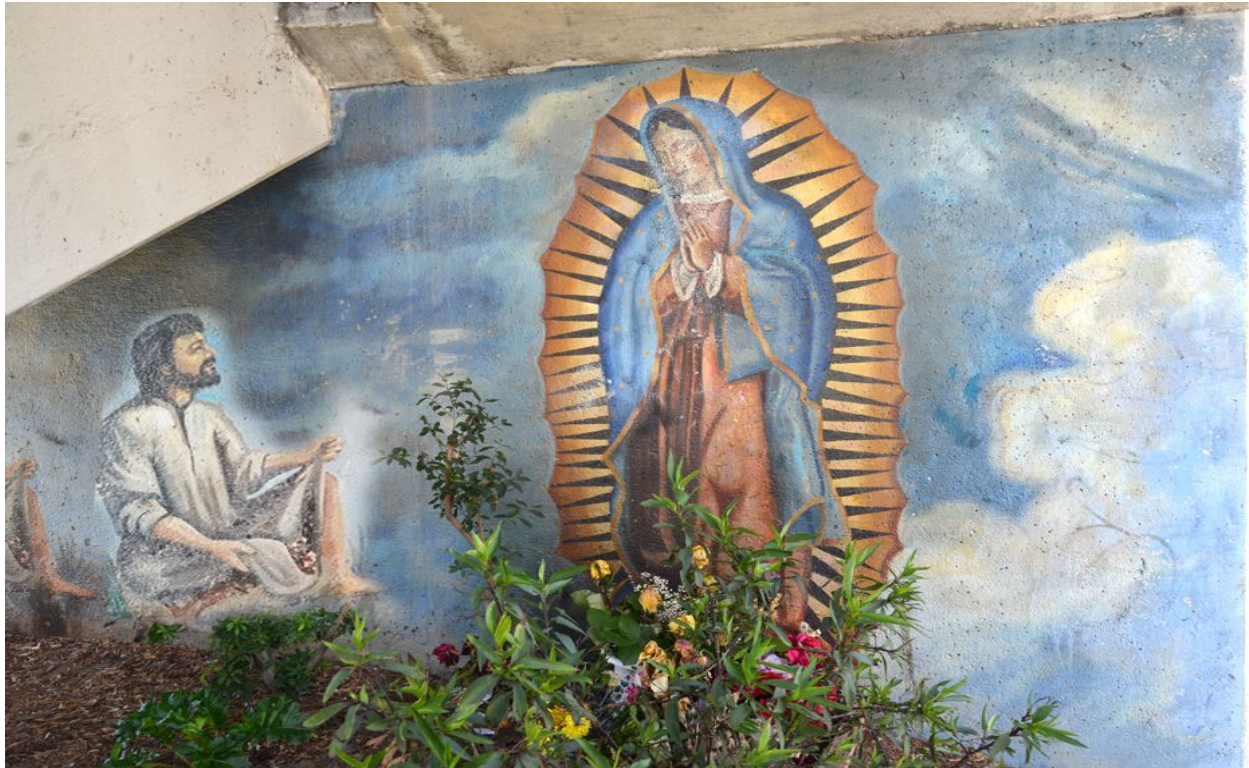
**Our Lady de Guadalupe and Saint Juan Diego  
Lemon Park Bridge murals by the community circa 1970's  
7'4" x 16'4"**

Problems identified were distorted coloring from graffiti eradication, general fading and lack of protective coating. Recommendations:

- Sand, clean, fill holes and paint on top existing art.
- Design enhancements: Move Juan Diego about half-way closer to the Our Lady de Guadalupe to be able to see him better.. Add cactus plants where he used to be.
- Add a gold paint to create a gilded look on the Our Lady de Guadalupe.
- Extend and fade sky area up higher than the existing mural.

*City Assistance:* Propose moving back the landscape, adding thick bark in front.

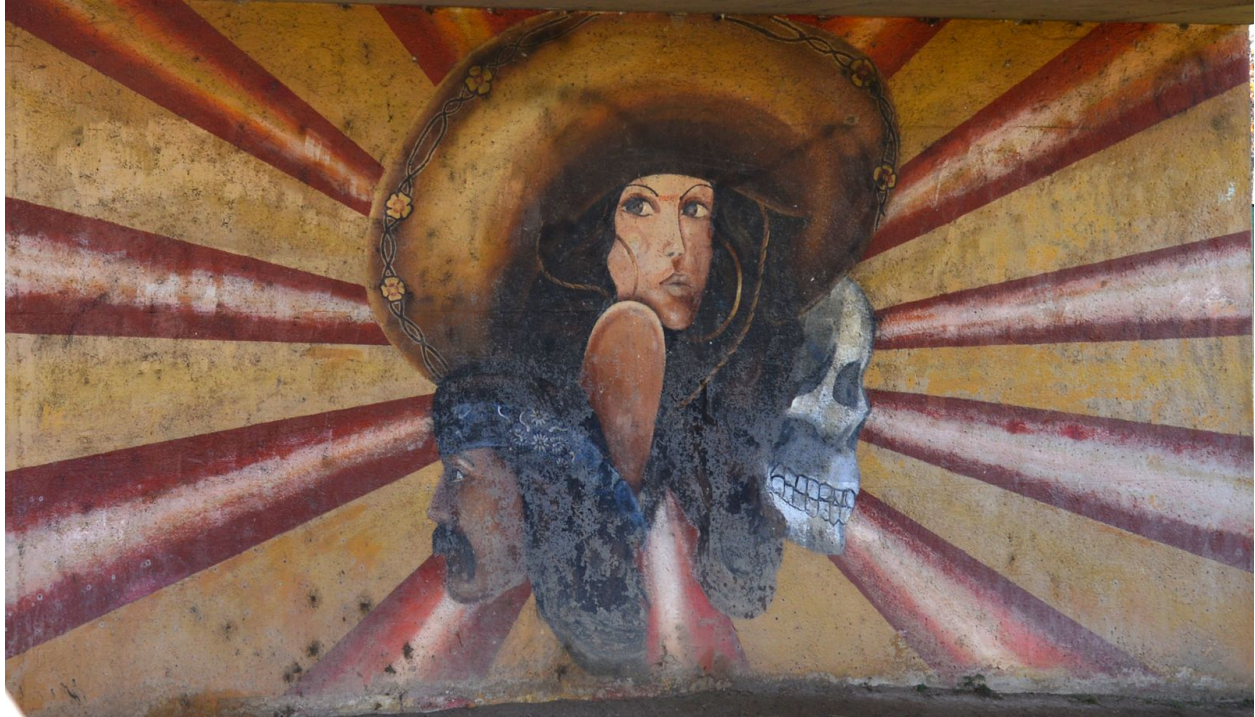
**“Sombrero Woman” by the Community Circa 1970’s  
7’4” x 16’4”**

This mural has Oxidation of the protective layer. Minor chipping and peeling. Holes in the concrete wall. Able to restore by prepping and painting the current mural. Recommendation:

- Remove oxidation, sand, clean, fill holes, and paint on top existing art. Maintain the same look and original art.
- *Materials:* paint, brushes, drop clothes, final protection UV coats.

*City assistance:* Ground Bark around the perimeter to protect mural.

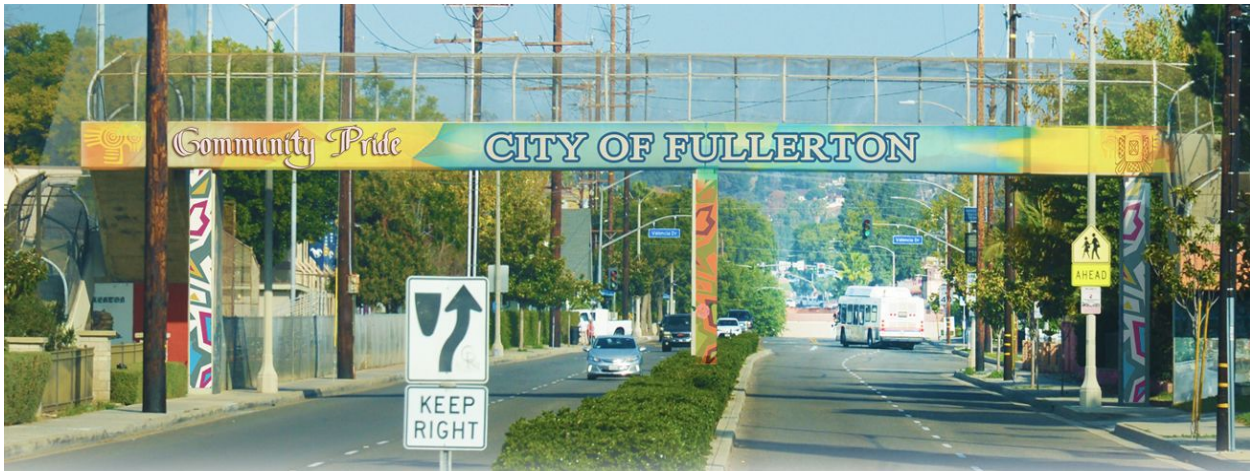
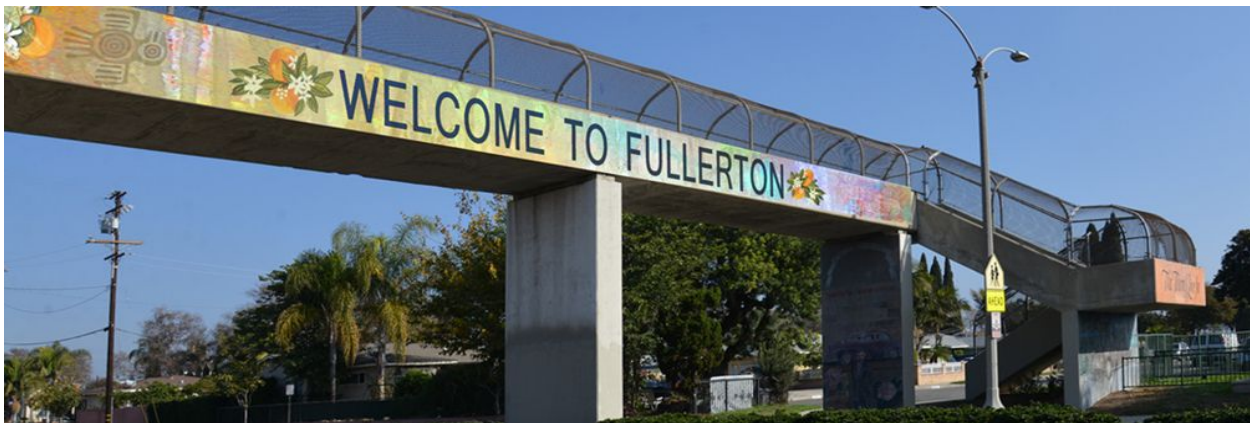
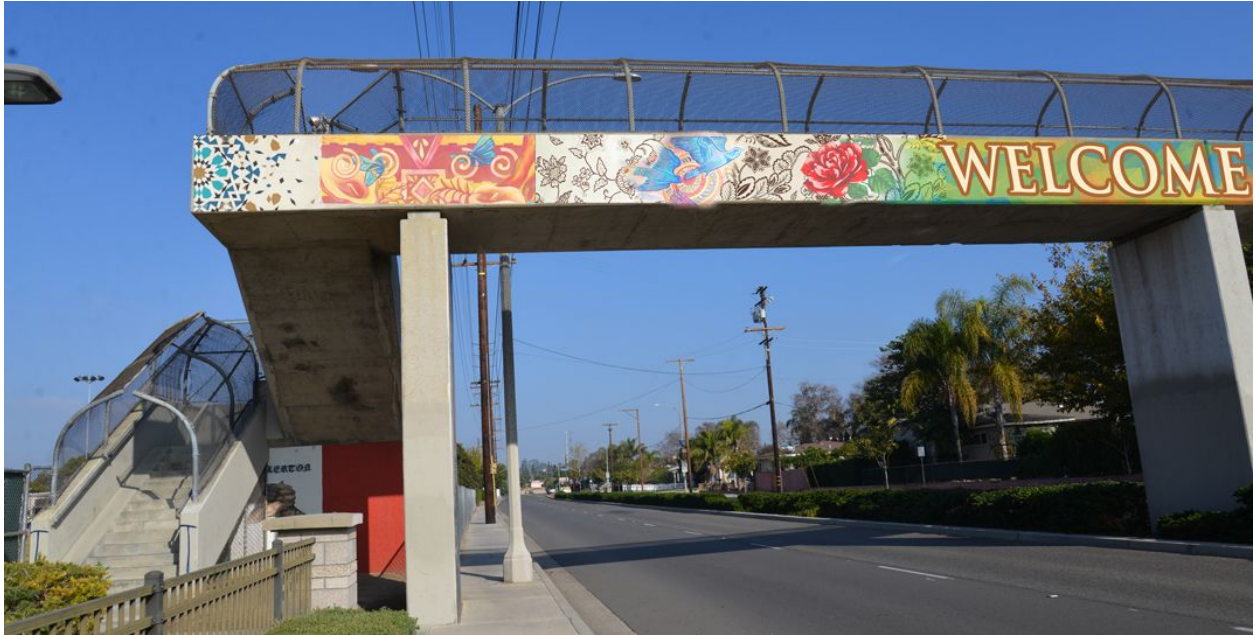
## Options and Themes

The design is open for discussion. These photoshop samples are visual ideas to spark conversation.

Along with this report, is the idea to add new art to other portions of the bridge -- a splash of color to the frontage. This will be a welcoming feature that ties in both sides of the bridge. A custom design mural frontage would be installed, painted on the polytab material off location with a possibility for community involvement. The polytab design can be created with volunteers at a community center. We will then install it to the bridge permanently. Adding the lettering as well also during the installation process.

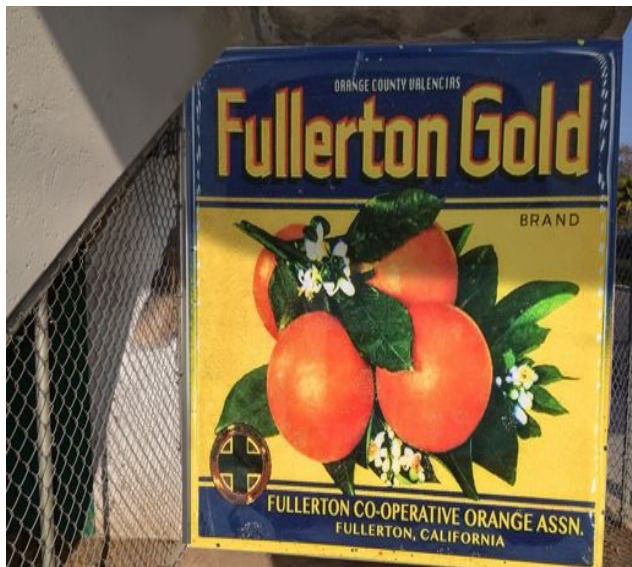
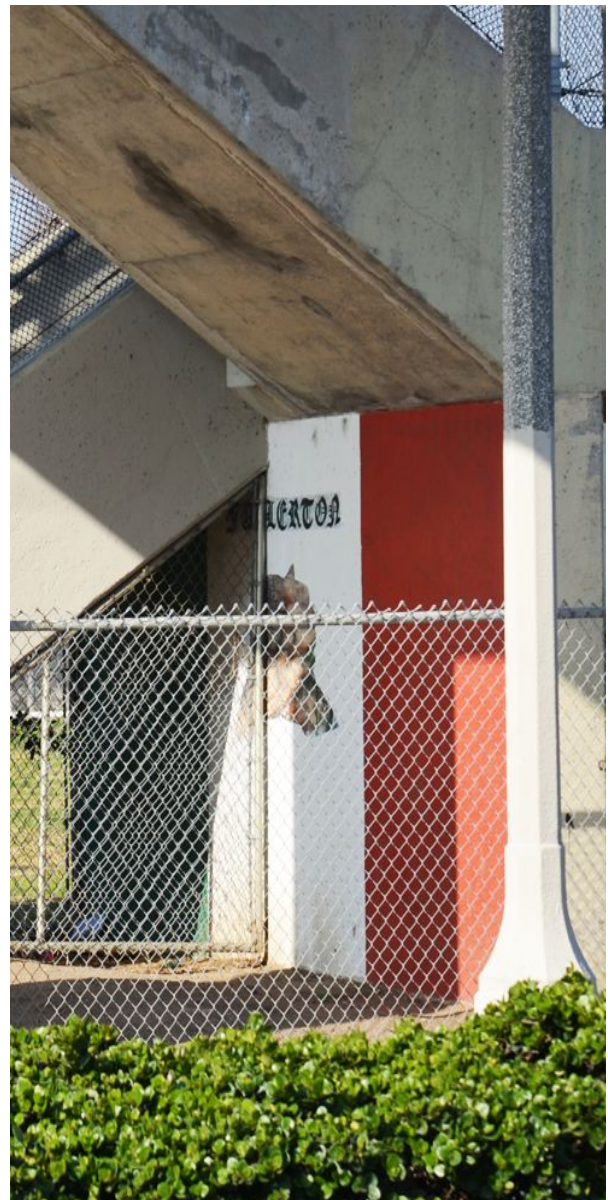
## Vintage Square Citrus Label

7' by 16' wall space with inside fenced area. Partially behind fence area.

Needs discussion on the structure of the area with the fence.

- We recommend changing this to a historical image, such as a vintage crate label that could be painted in the 7' by 7' foot area outside of the fencing. Can't see the mural properly or read Fullerton in entirety the way it is now. Hands image can be incorporated in the Vertical Panel to the right.
- Design Vintage label
- Apply Polytab

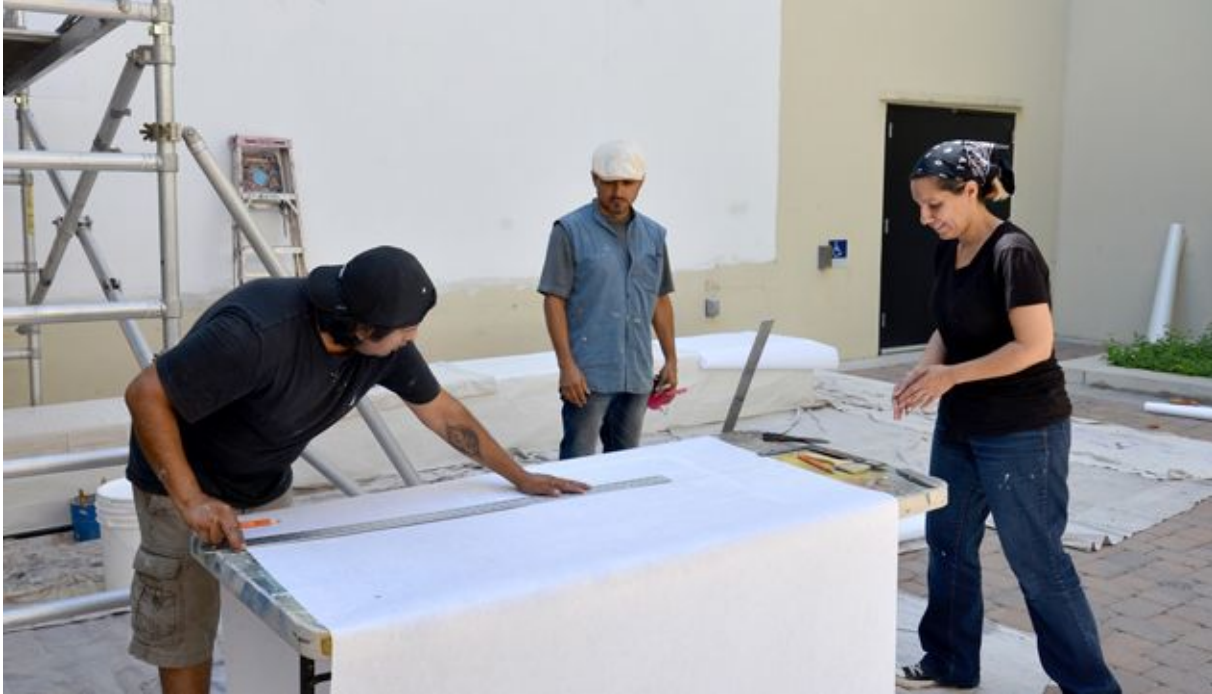
## MURAL FABRIC- POLYTAB INFORMATION

Polytab can be applied to stucco, masonry, and wood. Polytab is a non-woven fabric- Used in the garment industry the material is lighter than canvas and durable. The material is plyable to take on the form of the substrate that is being applied to, helping prevent cracks and chipping in murals. Polytab extends the life of the mural, keeping it in better condition for twice the length of the mural or more.

Applying this material to the wall, prior to painting, guarantees that the coats of latex paint most commonly used in mural painting will not crumble from the wall as does the conventional mural art that is painted on concrete or stucco substrate. Once it is on the wall, it is primed and then drawing and painting begins just like on a regular canvas.

The surface the fabric will be applied to a normal clean and primed wall (Acrylic Primer). An Acrylic Gel is used to adhere the fabric to the wall. Applying coats of gel over the edge seam and the wall help to create a seamless edge. Artex Nova Color Paints (Culver City) are used for the mural painting process.

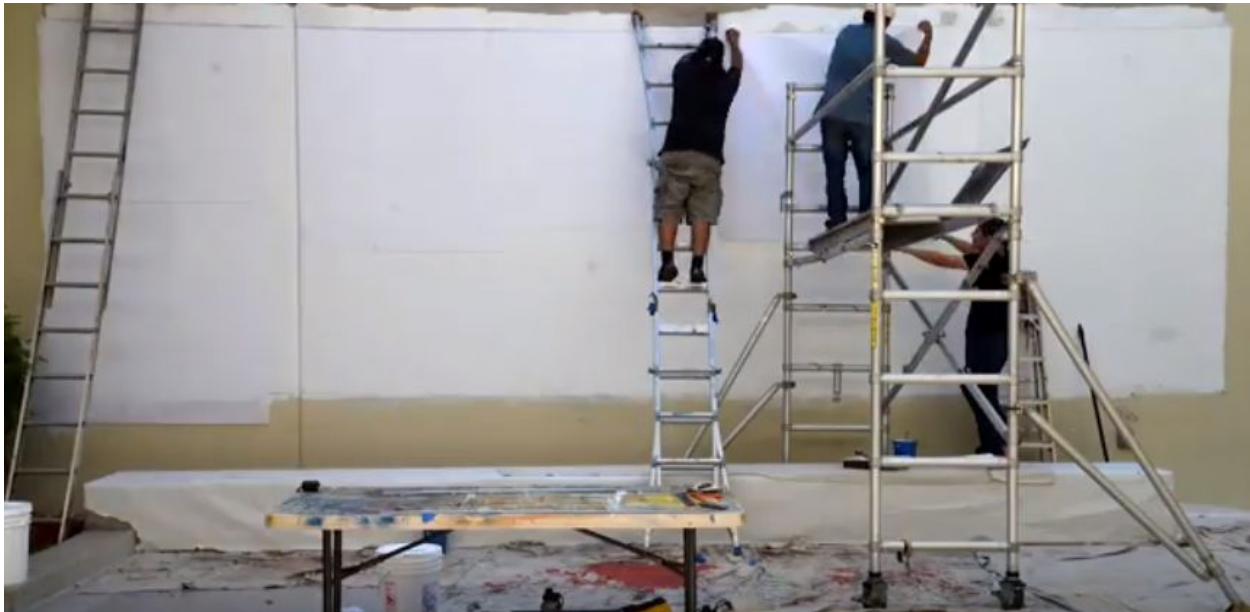
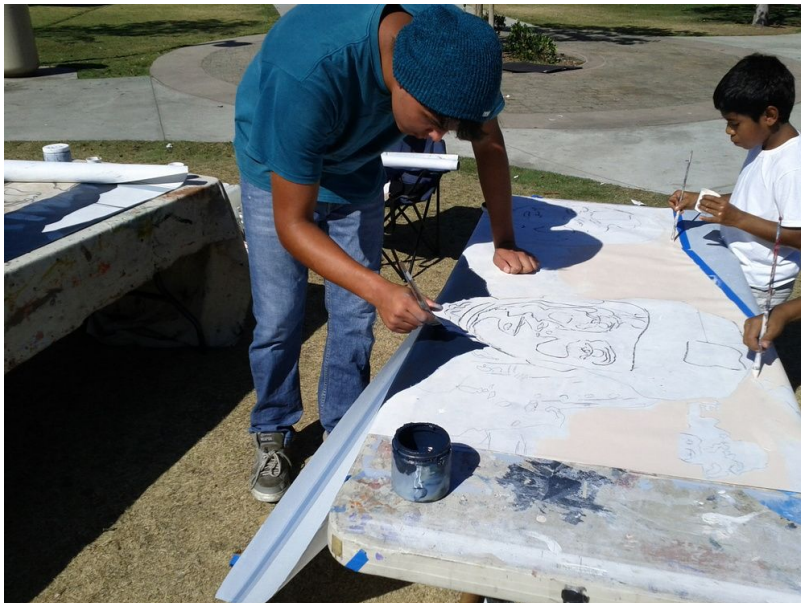
Murals can also be painted in the studio with this material, then installed and applied on location. This makes it more convenient than on-location painting. Unlike canvas, this material is non-organic, so it is resistant to rot and mold from exterior weather exposure.
